TITLE: Recognition and Correction of Sonic Fatigue Damage in Fighter Aircraft

Recognition and Correction of Sonic Fatigue Damage in Fighter Aircraft

Mr. Salvatore L. Liguore, Dr. Theodor H. Beier

The Boeing Company, PO Box 516

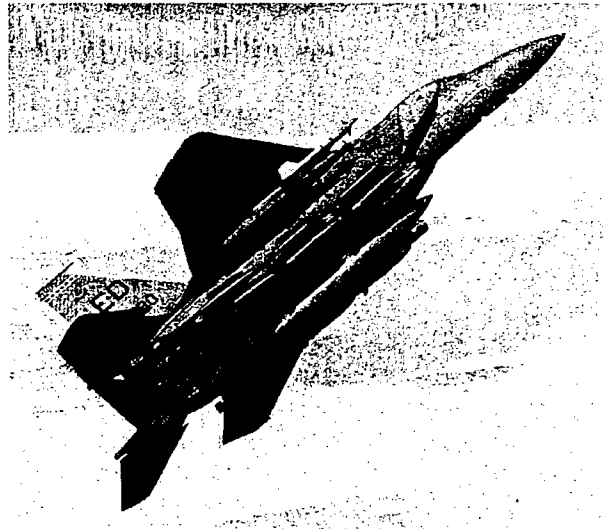
On fighter aircraft, secondary structures are lightly loaded during maneuvers, but they still experience cracking primarily due to dynamic loads from buffet, flow-induced noise, shock/boundary layer interaction, and turbulence. Acoustic loads are highest during high speed and low altitude missions for the lower surface and during high angle of attack maneuvers for the upper surface. On the lower surface, turbulent flow forms around external stores, Figure 1, and will be used as an example source of damage is discussing repairs. This noise is characteristically high in frequency (200 to 1000 Hz) and broad band in nature as will be shown in Figure 4.

Figure 1. On the Lower Surface, Turbulent Flow Forms Around External Stores

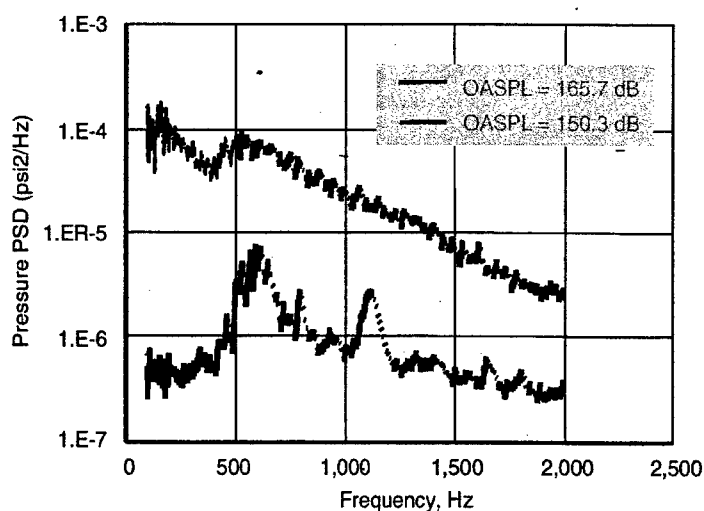
The increase in the acoustic spectrum on the fuselage skin at the critical locations from the addition of the pod may be seen in Figure 4. It may be noted that the spectrum levels are high over a wide frequency range. Therefore, strengthening the panel, which will increase its natural frequency, will not help, and in fact a change from 300 Hz to 500 Hz would be detrimental.

Other excitation sources mentioned herein have levels of similar magnitude. Engine exhaust plume spectra may be in the 165 dB to 170 dB range, and relatively flat over a wide range of frequencies. Acoustic spectra from engine inlets and weapons bays will

Figure 4. Incident Sonic Spectrum, With and Without Stores

have high broad-band levels, and in addition contain pure tones of very high amplitude. However, it will be impossible to tune the structural frequencies to avoid the tones because they change frequency with engine speed in the inlet case, and with Q in the weapons bay case.

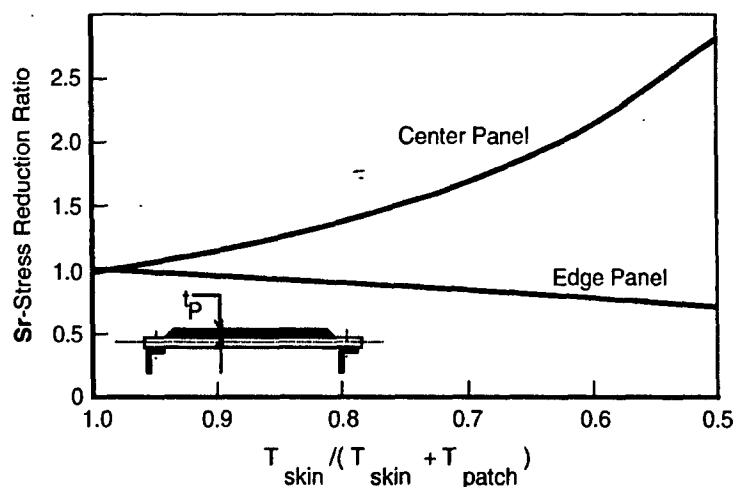
Reinforcement - The problem with repairs that involve stiffening only is that fatigue damage often appears on adjacent structure, because the dynamic energy is still present. Doublers mass load the substructure and cause higher dynamic bending moments at the panel edges, which may change the response of near-by panels. See Figure 5, which shows the reduction ratio in stress for the patch application as a function of doubler thickness. It may be noted that as the doubler thickness increases, the reduction ratio at the panel edge decreases below 1.0, which indicates an actual stress increase. For example, if a panel is repaired with a doubler of equal thickness, the stress at the panel center is reduced, but the stress ratio at the edge is 0.75, which is a stress increase of 33%. This will likely cause the failure to migrate to the substructure.

Figure 5. The Effect of Skin Reinforcement on RMS Panel Response

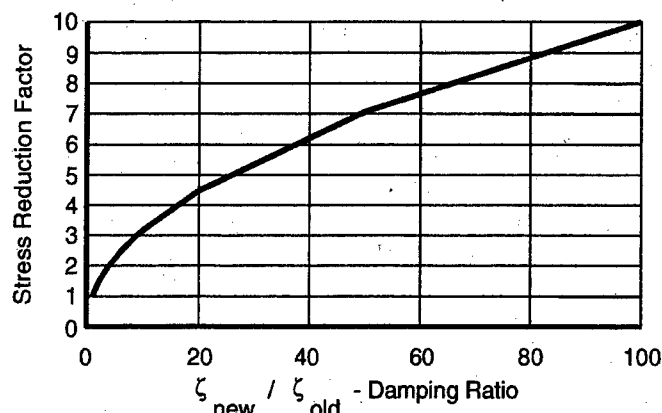
In linear dynamics systems, damping is inversely proportional to the response. Hence, as the damping increases the peak response decreases proportionally. Under broad band random vibration, the response is inversely proportional to the square root of the damping. Hence, the damping would have to be quadrupled in order to decrease the root mean square (RMS) response by 50%. This relationship is shown graphical in Figure 6. Referring to the figure, if the damping is increased by a factor of 6 to 7, a factor which can be easily achieved, the stress reduction in the panel is 2.5 as with the doubler. Unlike the simple doubler, the stress at the edge is also decreased by a similar amount.

Figure 6. The Effect of Damping on Single Mode RMS Response

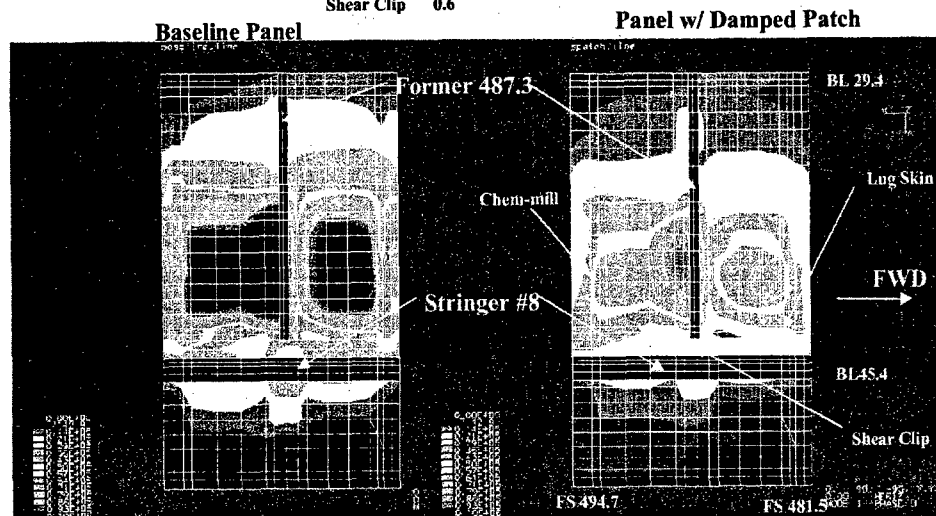
Normalized Principle Stress Reductions:

Location	Ratio (BL w/Patch to BL)
Lug Skin	0.45
Chem-Mill	0.4
Shear Clip	0.6

Figure 9. Random Vibration Analysis of Panel with and without Patch

The purpose of the damped doubler is to reduce loads in the skin and in the former through damping. The design was verified through finite element analysis. The damping performance of the patch was determined through modal strain energy analysis¹⁴. The panel was analyzed using random response analysis to determine overall RMS loads reduction, Figure 9. The contour plot shows how the stresses in the skin panel are expected to change. Large reductions are expected in the skin panel with smaller reductions at the edges. The modal damping predicted by the analysis was on the average of $\zeta = 5\%$ for the lowest 5 modes at the temperature of interest, which is an increase of over 4.
